# PAST TIMES: STORIES FROM THE SHELDON'S PAST

## *Old Trestle Was Site of 1893 Train Wreck*

**Jan Albers, former Executive Director, Henry Sheldon Museum**

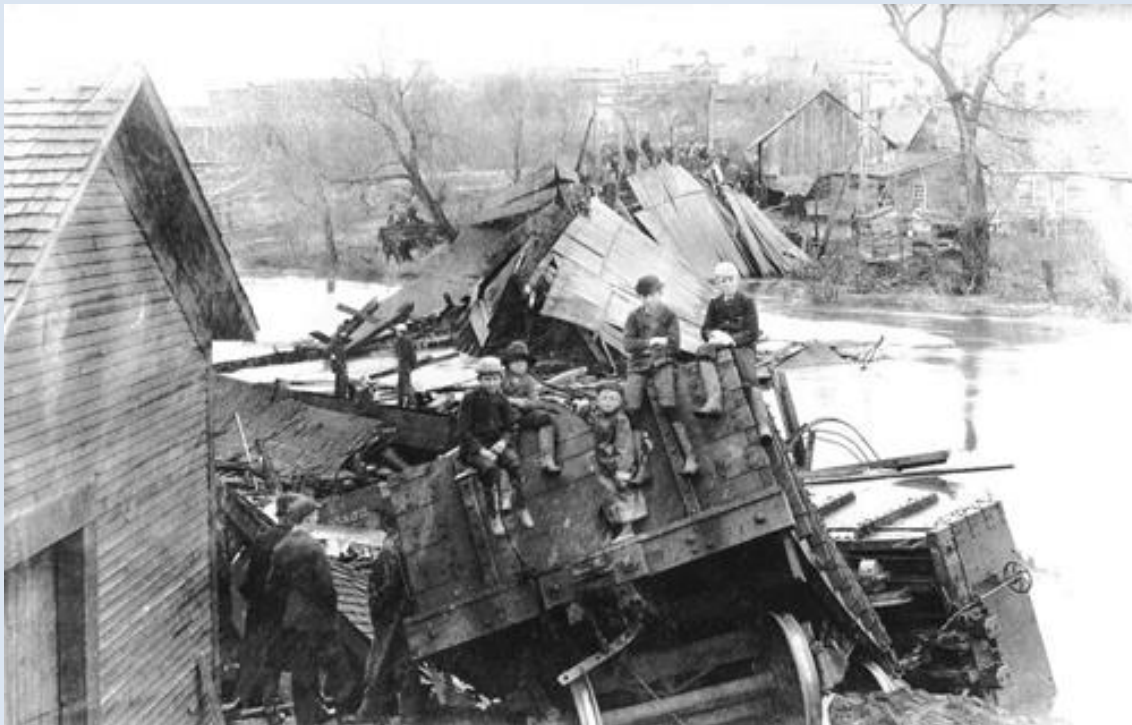
**Following the train derailment of 1893. Collection of Henry Sheldon Museum**

The spectators found a shocking scene of devastation. The wooden railway trestle that crossed Otter Creek at the bottom of Water Street had collapsed under the weight of a heavily-loaded twenty car coal train. The engine, boxcars and five coal cars crossed just fine, but as the rest of the coal cars came on to the two hundred foot span, the trestle gave way.

The devastation was sudden and catastrophic. The first reporter on the scene said that, "The wreck is total and indescribable," though this did not deter him from doing his job of describing it. Early speculation was that the rainy weather and high water of the previous 24 hours had undermined the trestle's central pier. Others suspected that a car had done off the rails and hit the edge of the bridge, causing it to collapse. From the state of the wreckage, it was deduced that, "The bridge gave way all over. As it sank, it careened to the westward. A more complete wreck than the bridge presented it would be hard to imagine."

Investigations into the cause of the 1893 accident concluded that the original wooden trestle had been too flimsy to support the ever-heavier trains that were using it. The structure was built for the relatively light weights of the first trains, but by 1893 each coal car weighed over 30,000 pounds in itself, and carried a further 95,000 pounds of coal. The whole train would have weighed in at over 500 tons. The conclusion reached was that, "[The trestle's] breaking was merely a question of time." According to one crusading reporter, "The question is forced upon the public by this accident, How many more unsafe bridges are there on the line?" This is a question that has not gone out of style when we look at our own roads and railways.
